PROJECT NO. 15BPR.18

BRIDGE NO. 63

PRESTRESSED GIRDER REPAIR LOCATIONS

SPAN C

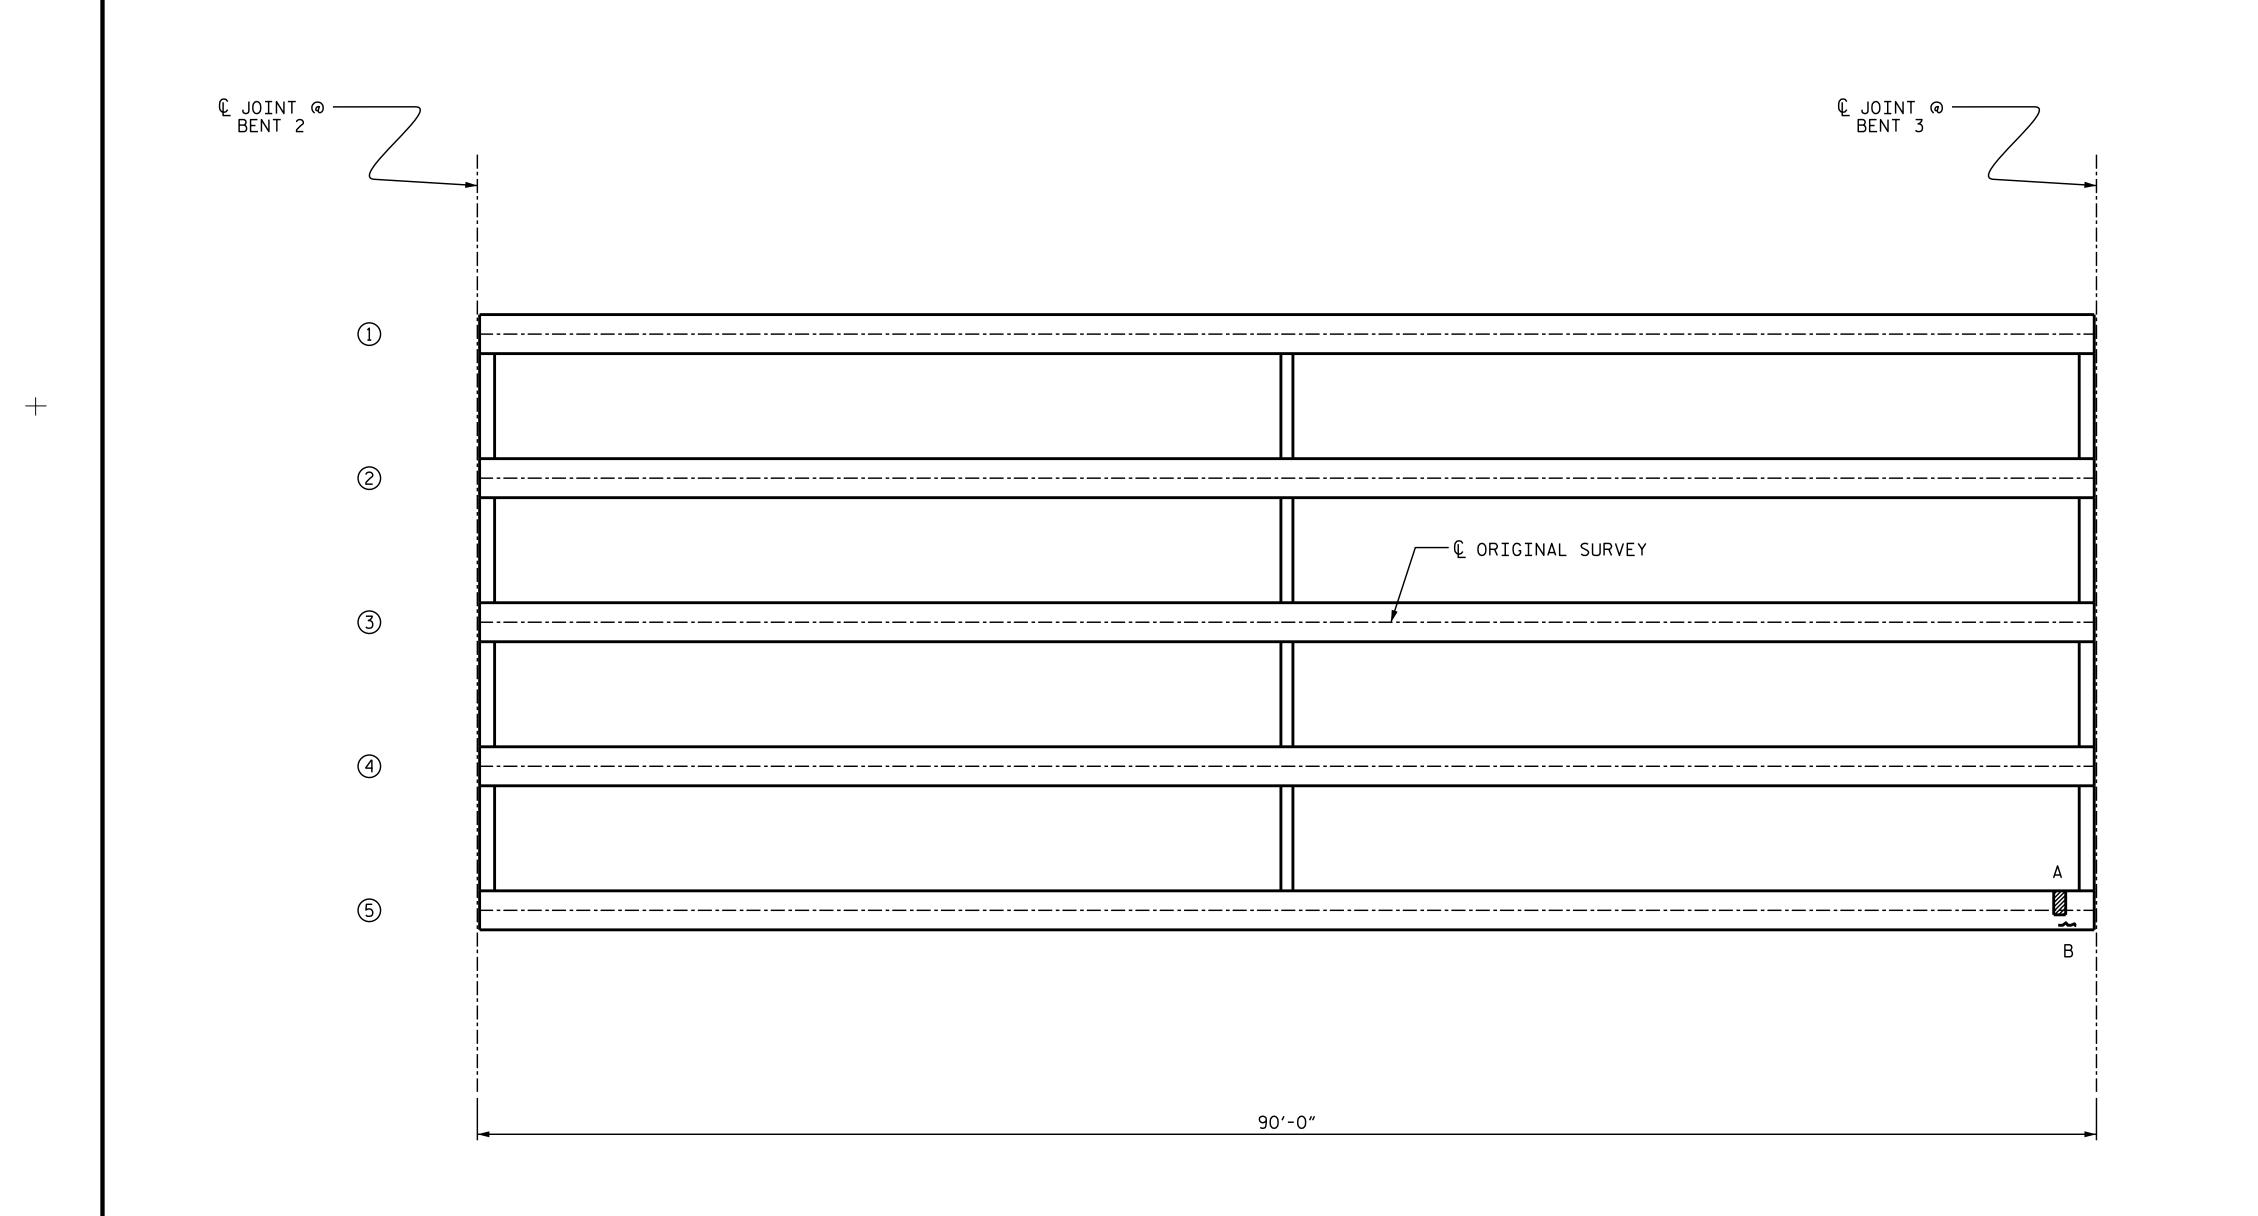
PRESTRESSED GIRDER REPAIR LOCATIONS

(OTHER LOCATIONS MAY EXIST, SEE NOTES)

GIRDER REPAIR LOCATIONS			
GIRDER	LOCATION	REPAIR SIZE (L × W )	LABEL
5	BT.FL.	1'-4" × 8"	Α
5	T.F. TO WEB	3'-0"ERI	В

FOR PRESTRESSED GIRDER REPAIR DETAILS, SEE "PRESTRESSED GIRDER REPAIR DETAILS AND SUMMARY" SHEET.

THE LOCATIONS AND DIMENSIONS OF THE AREAS FOR REPAIR ARE BASED ON THE BEST INFORMATION AVAILABLE. THE CONTRACTOR, IN CONJUNCTION WITH THE ENGINEER, SHALL VERIFY THE LOCATION AND EXTENT OF REPAIR AREAS PRIOR TO GIRDER REPAIR.
